# Advanced Failure Modelling for Hydroelectric Infrastructure

**Abstract**—In this study, failure analysis of pipe system at a micro hydroelectric power plant is investigated. Failure occurred at the pipe system in the powerhouse during shut down operation of the water flow by a valve. This locking had caused a sudden shock wave, also called “Water-hammer effect”, resulting in noise and inside pressure increase. After visual investigation of the effect of the shock wave on the system, a circumference crack was observed at the pipe flange weld region. To establish the reason for crack formation, calculations of pressure and stress values at pipe, flange and welding seams were carried out and concluded that safety factor was high (2.2), indicating that no faulty design existed. By further analysis, pipe system and hydroelectric power plant was examined. After observations it is determined that the plant did not include a ventilation nozzle (air trap), that prevents the system of sudden pressure increase inside the pipes which is caused by water-hammer effect. Analyses were carried out to identify the influence of water-hammer effect on inside pressure increase and it was concluded t

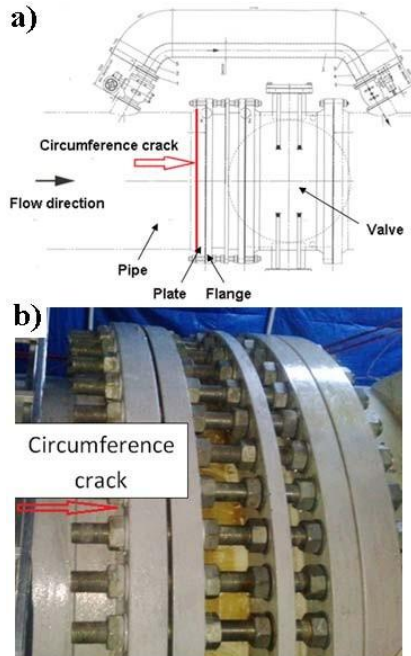
As can be seen in Fig. 2, circumference crack had been constituted at the flange-pipe welding zone.

Fig. 2 General view of the flange-plate-pipe system and circumference crack

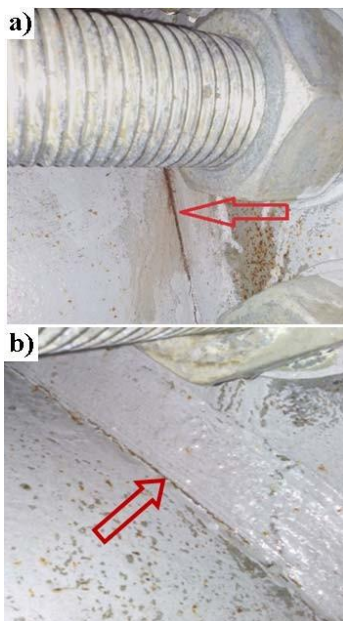
Fig. 3 Crack formation in pipe-plate welding zones

After detailed investigation it is concluded that crack had been propagated in pipe-plate welding zones (Fig. 3) and in pipe-flange plate welding zones (Fig. 4).

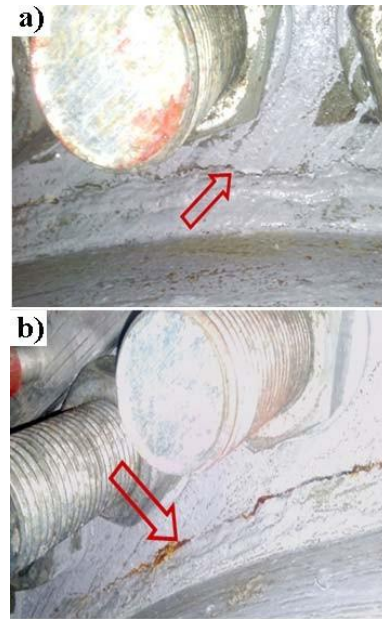
Fig. 4 Crack formation in pipe-flange welding zones

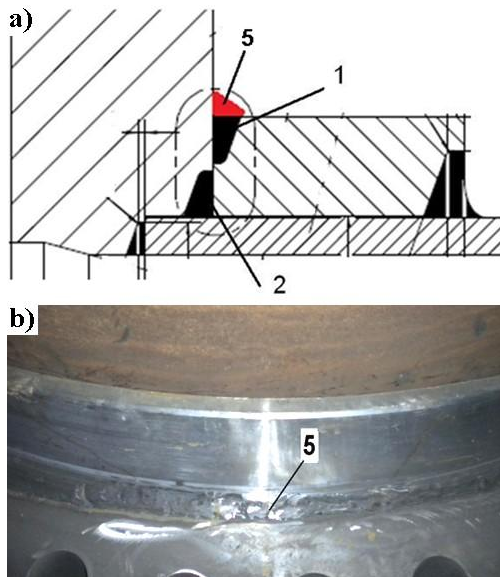
Weld seams 1 and 2 are applied between plate and flange, weld 3 between plate and pipe and weld 4 between pipe and flange as can be seen in Fig. 7. For further detailed weld analysis it is investigated if these mentioned four weld seams are applied correct as can be seen in Fig. 7. During observation an additional weld seam, which was not mentioned in assembly drawing in Fig. 7 was detected, as can be seen in Fig. 8.

Fig. 8 Weld seam no.5 (b), which was not mentioned in assembly drawing as can be seen in Fig. 7

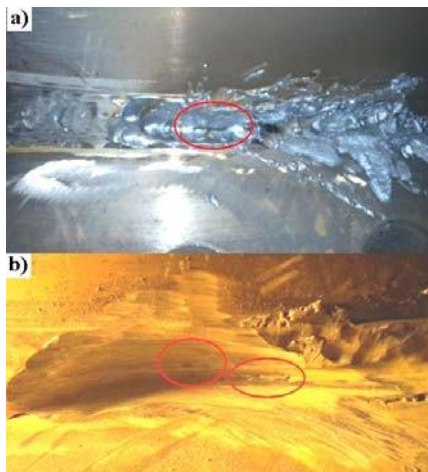
To analyze weld seam 1 and 2, weld seam 5 was grinded. After grinding it is detected that weld groove for weld 1 and 2 was constituted, but no welding process for weld 1 and 2 was applied, as can be seen Fig. 9. Therefore, a gap under weld 5 existed.

After weld seam analysis it is concluded that assembly of the plate-flange-pipe system was not applied correctly. Weld seams 1 and 2 were not applied; only weld grooves of weld 1 and 2 were constituted. The unfilled grooves 1 and 2 acted as inside cracks resulting in a strong notch effect. Stresses raised at this region caused crack propagation to the weld seam 5. By further investigation it is detected that weld groove for weld 3 was prepared incorrect. Groove angle was 70° instead of 20°. This had resulted in an increase of weld thickness from 25 mm to 110 mm, as can be seen in Fig. 10. This has resulted in a decrease of safety of the pipe-plate system, due to the low strength and high brittleness of weld seam according to base material.

Fig. 9 Weld groove of weld seam 1 and no welding process

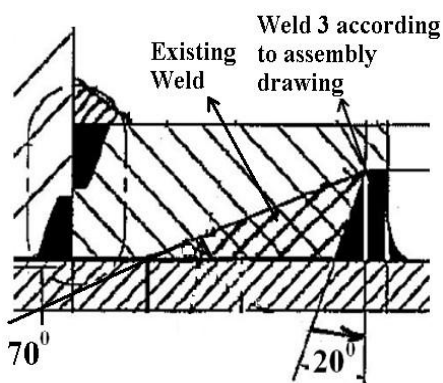
Fig. 10 Incorrect weld groove of weld seam 3
