# Environmental Management of Mining Wastes

**Abstract**—By GEO5 FEM program with four rockfill slope modeling and stability analysis was performed for S1, S2, S3 and S4 slopes where landslides of the shalefills were limited. Effective angle of internal friction ( $\phi^\circ$ ) 17°-22.5°, the effective cohesion ( $c'$ ) from 0.5 to 1.8 kPa, saturated unit weight 1.78-2.43 g/cm<sup>3</sup>, natural unit weight 1.9-2.35 g/cm<sup>3</sup>, dry unit weight 1.97-2.40 g/cm<sup>3</sup>, the permeability coefficient of  $1 \times 10^{-4}$  -  $6.5 \times 10^{-4}$  cm/s. In cross-sections of the slope, GEO 5 FEM program possible critical surface tension was examined. Rockfill dump design was made to prevent sliding slopes. Bulk material designated geotechnical properties using also GEO5 programs FEM and stability program via a safety factor determined and calculated according to the values S3 and S4 No. slopes are stable S1 and S2 No. slopes were close to stable state that has been found to be risk. GEO5 programs with limestone rock fill dump through FEM program was found to exhibit stability.

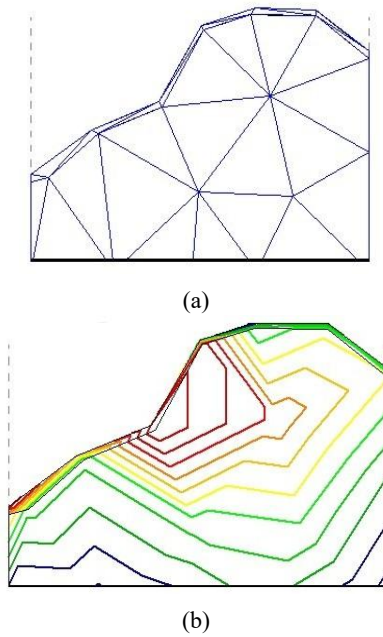
Fig. 3 (a) S2 section of the study area slopes 10 m mesh topology, (b) Deformation FEM stability analysis GEO5 programs, cut red 30mm unstable displacement

The stack S2 hillside after rains made the small size of the movements that have been identified in field studies. No. S2 to develop pile slope is covered with talus and 10 m mesh FEM GEO5 programs were created with the program (Fig. 3 (a)). S2 The top of the stack and the maximum height

difference between the heel point 45 m, the slope of the maximum height of 50 m, the slope of the surface tilt angle is  $40^\circ$ .

Drilling carried out by the Special Provincial Administration; according to information obtained from the panhandle talus thickness varies from 11 to 20 m. The fill S2 in were the investigation of the slope where the ground water level 35 m was observed at the base S2. The advent of landslides in the slope stability calculations made in  $c' = 1.9$  kpa,  $\phi' = 22^\circ$ ,  $\gamma_{nat.} = 1.97 - 2.27$  g/cm<sup>3</sup>, and are used to  $\gamma_{dry}$ . According to  $\gamma_{dry}$  and  $\gamma_{nat}$  calculated separately on the potential slip surface deformation contour values seen in Fig. 3 (b).

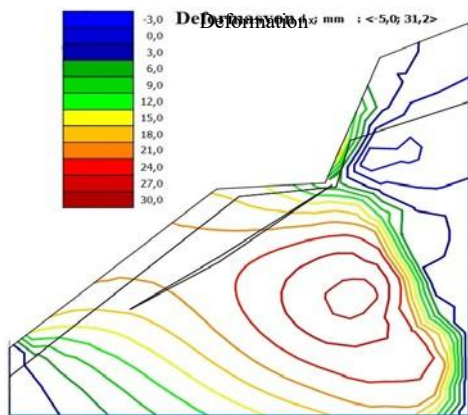
Fig. 4 S3 heel unfilled limestone slopes of the study area section, sensitivity analysis FEM GEO5 programs. Deformation, Red unstable cutting surface

S3 after precipitation in the observations on the slope of a small rupture, leakage occurred was observed. Similarly the slope S3 indicates instability and displacement reached 30mm (Fig. 4).

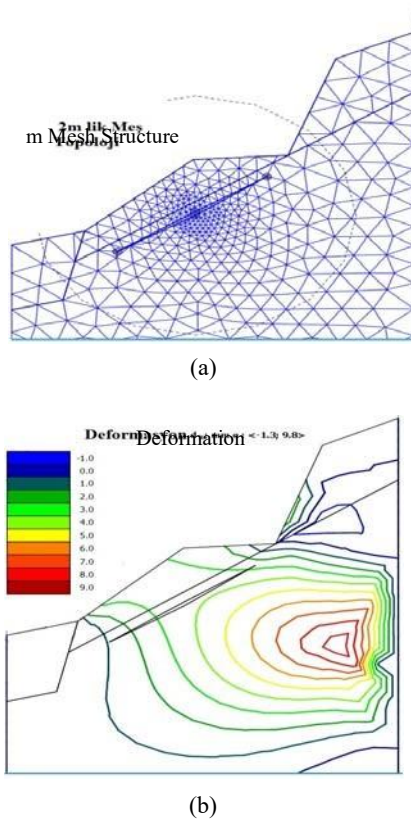
Fig. 8 (a) S3 heel -filled limestone slopes of the study area 2 m mesh topology section (b) geo5 FEM sensitivity analysis, Deformation, Red unstable cutting surface

Weak adverse effect with the sliding surface as shown in Fig. 8 (a) and a weak surface tension in the design frequency 2 m mesh weave texture is formed. In this design, even with

the heel stone fill that provided stability, security coefficient values exceeded the value of 3.

When using a filler to form the slope S3 instabilities deformation displacement are shown in Fig. 8 (b) and displacement m below the maximum possible shift of the substrate 20 has reached 9 mm (Fig. 8 (b)).

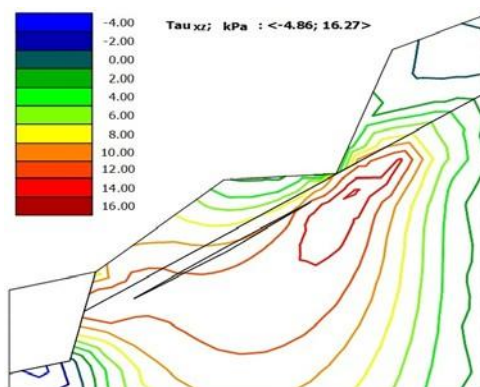
Fig. 9 S3 heel -filled limestone slopes of the study area (1 m mesh) cross-section, sensitivity analysis FEM GEO5 programs. Shear stress, shear Red unstable surface

S3 slope instabilities will form filler when used in kPa shear stress is shown in Fig. 9 , and ranged from 10 to 16 kPa and 16 kPa reached a possible shift in the base .
