Advances in Friction Welding of Composite Materials

E. K. Thompson, A. M. Patel

Massachusetts Institute of Technology, Cambridge, USA

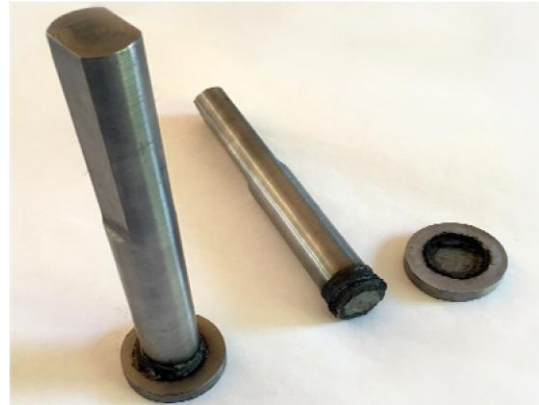
Fig. 1 shows a friction-welded specimen before and after being subjected to tensile testing. As can be seen in the figure, failure did not occur in the welded joint but rather in the porous stainless steel disc at a distance of about 2 mm away from the edge of the wrought iron tube, producing a very rough surface characterizing brittle fracture. In fact, it revealed that the solid iron tubular end penetrated into the porous disc, allowing some porous stainless steel to intrude into it and block that tube. The results obtained for the load-carrying capacity of the tensile test specimens was, therefore, not an indication of the strength of the friction-welded joint, but of the sintered porous stainless steel. As it is always the case with sintered porous metals, values of the load-carrying capacity showed a scatter around an average of 35 kN. Evidently, that value cannot be used to determine the strength of the frictionwelded joint as previously mentioned.

Fig. 1 A friction-welded specimen before and after a tension test

the combined action of high temperature and pressure, with the final outcome being strong porous stainless steel in the area. In fact, that explains the mode of failure experienced during the tensile testing of the friction-welded joint, where brittle fracture occurred in the high-porosity stainless outside both the HAZ of the stainless steel and the interface of the welded joint. In fact, that finding is very useful in the design of the configuration of friction welded joints. Components composed of highly porous and solid parts of different parent metals can be produced by friction welding, thus expanding the range of powder metallurgical parts, which have controlled unique structures.

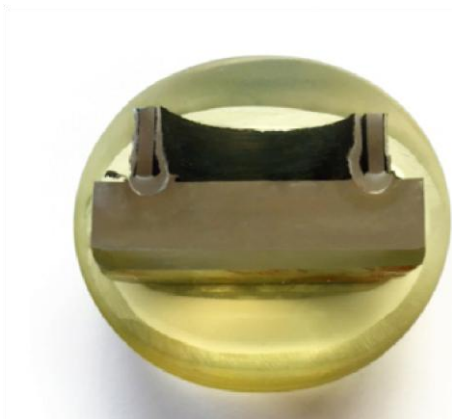
An axial macroscopic section of a friction-welded joint is shown in Fig. 3. The line along which friction welding took place appears as a well-defined trapezoid with a convex base. In fact, it is actually the edge of the wall of the iron tube, which sank into the sintered porous stainless steel disc during the friction welding process, producing an interlocking between those two parts. The heat-affected (HAZ) zone in the sintered porous stainless steel appears as an arch-shaped narrow layer under that trapezoid. Naturally, the picture shows just a cross section, and the HAZ is actually a ring coaxial with the iron tube and having that cross section. The figure also indicates that part of the iron tube was

bent inside the tube creating a short thin tube coaxial with the original one.

Fig. 3 An axial macroscopic section of a friction-welded joint
