# Advanced Failure Modelling for Hydroelectric Infrastructure

**Abstract**—In this study, failure analysis of pipe system at a micro hydroelectric power plant is investigated. Failure occurred at the pipe system in the powerhouse during shut down operation of the water flow by a valve. This locking had caused a sudden shock wave, also called “Water-hammer effect”, resulting in noise and inside pressure increase. After visual investigation of the effect of the shock wave on the system, a circumference crack was observed at the pipe flange weld region. To establish the reason for crack formation, calculations of pressure and stress values at pipe, flange and welding seams were carried out and concluded that safety factor was high (2.2), indicating that no faulty design existed. By further analysis, pipe system and hydroelectric power plant was examined. After observations it is determined that the plant did not include a ventilation nozzle (air trap), that prevents the system of sudden pressure increase inside the pipes which is caused by water-hammer effect. Analyses were carried out to identify the influence of water-hammer effect on inside pressure increase and it was concluded t

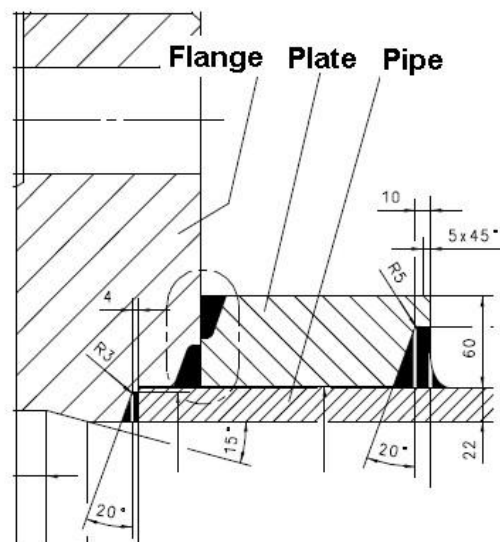
Fig. 5 Technical drawing of the pipe-plate-flange system

The design of the flange-pipe region can be seen in Fig. 5. To strengthen the pipe, a plate is welded at four regions to the pipe and flange. Flange material is steel St 52-3.

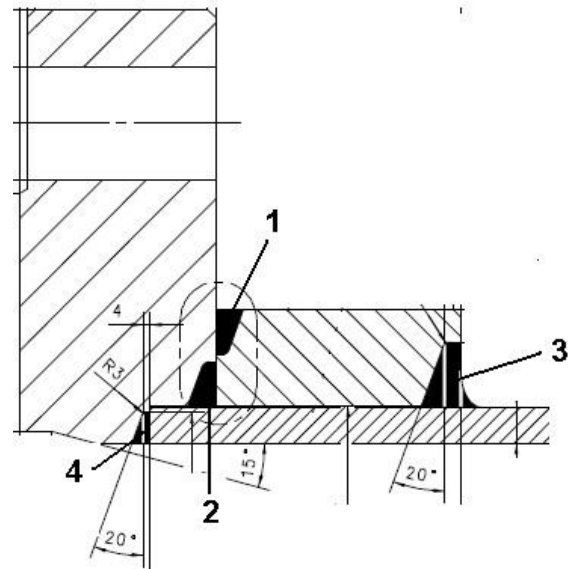
Fig. 7 Assembly drawing of the plate-pipe system

Weld seams 1 and 2 are applied between plate and flange, weld 3 between plate and pipe and weld 4 between pipe and flange as can be seen in Fig. 7. For further detailed weld analysis it is investigated if these mentioned four weld seams are applied correct as can be seen in Fig. 7. During observation an additional weld seam, which was not mentioned in assembly drawing in Fig. 7 was detected, as can be seen in Fig. 8.

After weld seam analysis it is concluded that assembly of the plate-flange-pipe system was not applied correctly. Weld seams 1 and 2 were not applied; only weld grooves of weld 1 and 2 were constituted. The unfilled grooves 1 and 2 acted as inside cracks resulting in a strong notch effect. Stresses raised at this region caused crack propagation to the weld seam 5. By further investigation it is detected that weld groove for weld 3 was prepared incorrect. Groove angle was 70° instead of 20°. This had resulted in an increase of weld thickness from 25 mm to 110 mm, as can be seen in Fig. 10. This has resulted in a decrease of safety of the pipe-plate system, due to the low strength and high brittleness of weld seam according to base material.
